Bearmark Home Inspection LLC

PROPERTY INSPECTION REPORT

Concerning: 1234 Test Street
(Address of Inspected Property)

Wednesday, May 13, 2009
(Date)

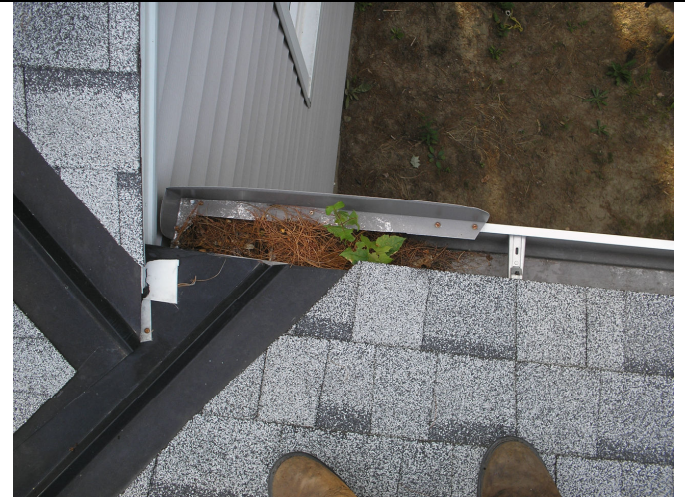
1. There is debris in the gutters.
2. Recommend sealing cracks in drive.
3. The front steps to house cracked. Recommend repair to prevent trip hazard.
4. Front porch has a negative pitch towards house.

Debris in gutter.

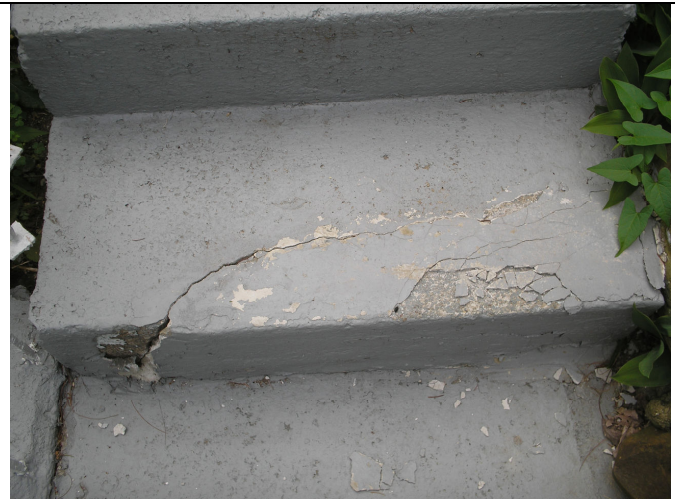
Front steps cracked.

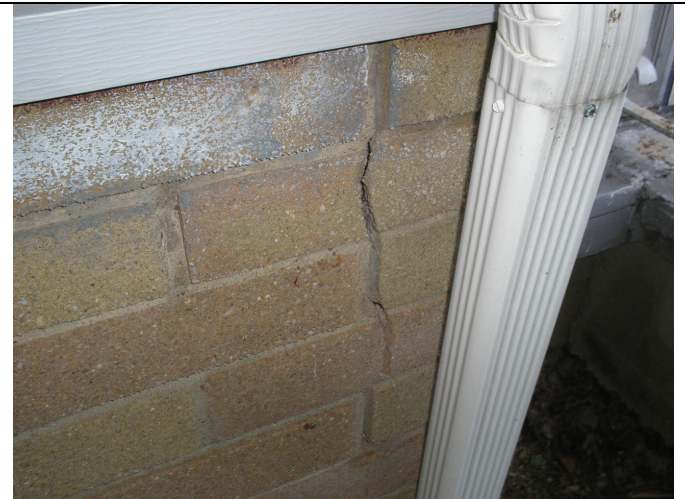
5. Front brick fascia has two cracks. Unable to determine the condition of the underlying materials.
6. Front retaining wall bowed and cracked.
7. The soil level is higher than recommended and in contact with the siding materials mainly along the East and South windows. Recommend lowering the soil line to help prevent damage to the siding materials.

Crack in front fascia.

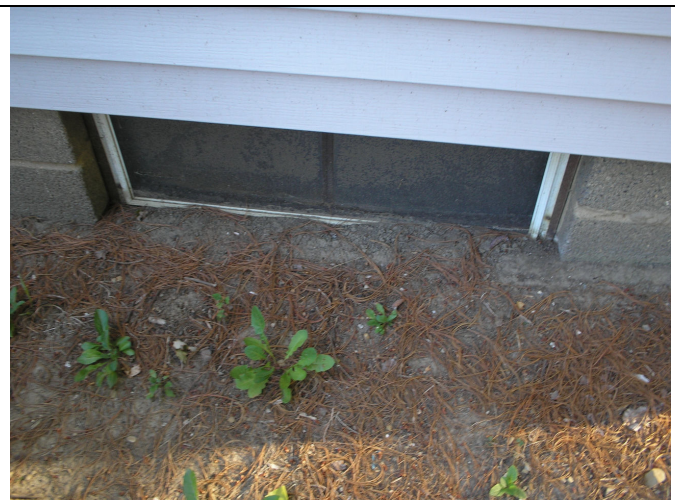
High soil line at windows.

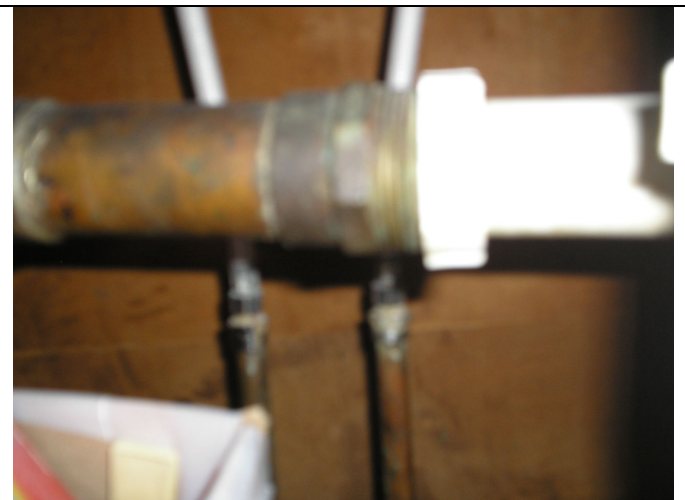
1. No water shut off valves for kitchen and bath sinks.
2. Leak under bath sink at bowl.
3. Hot/Cold reversed in hall bath sink.
4. Sink and tub/shower drain slow in hall bath.
5. Transfer valve for tub/shower in hall bath leaks at steam.

No water shut off valves under kitchen sink.

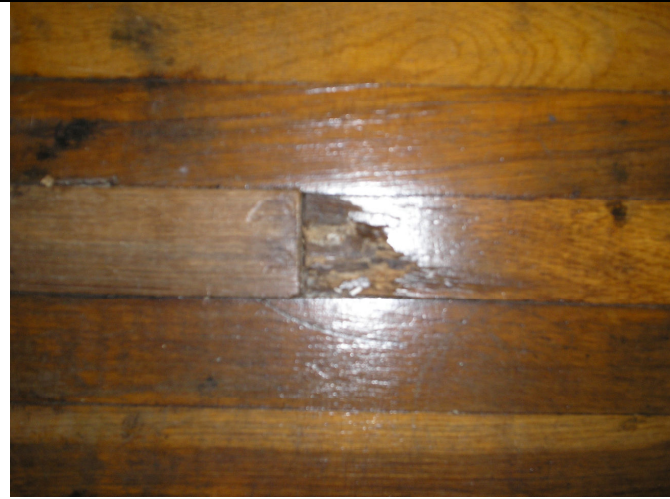
11. Wood rot was noted mainly along the rear back bedroom. Unable to determine the condition of the underlying materials.
12. Recommend hand rail for basement stairs.

Wood rot in back bed room.

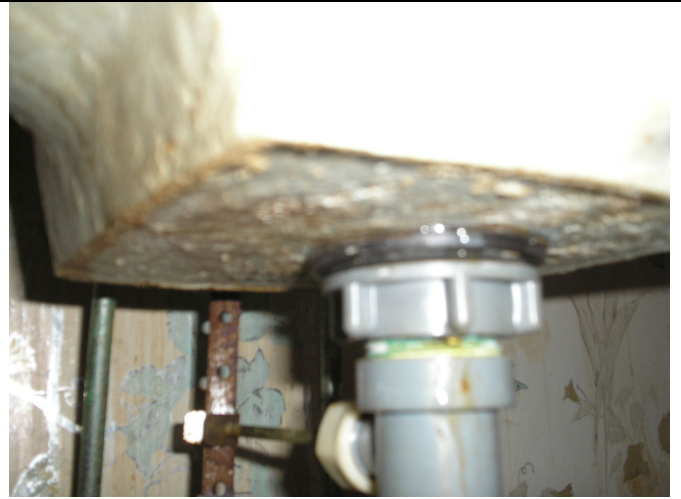
Leak under bath sink.

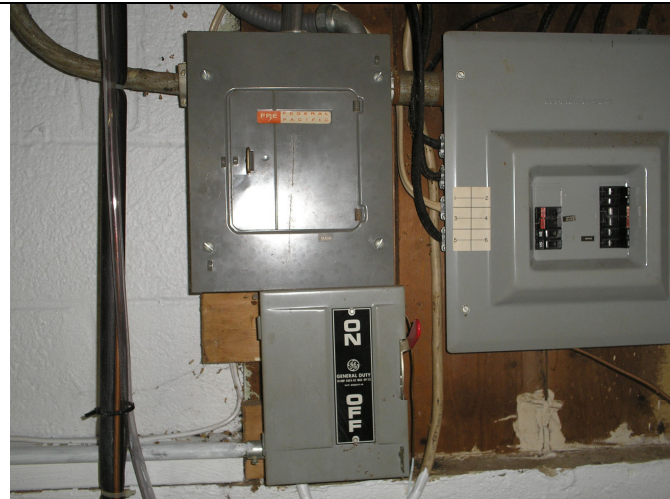
7. Disconnect placed too close to main panel. Unable to open panel without turning off panel.
8. The basement light fixture above panel did not respond to the control.

Disconnect in way of panel.

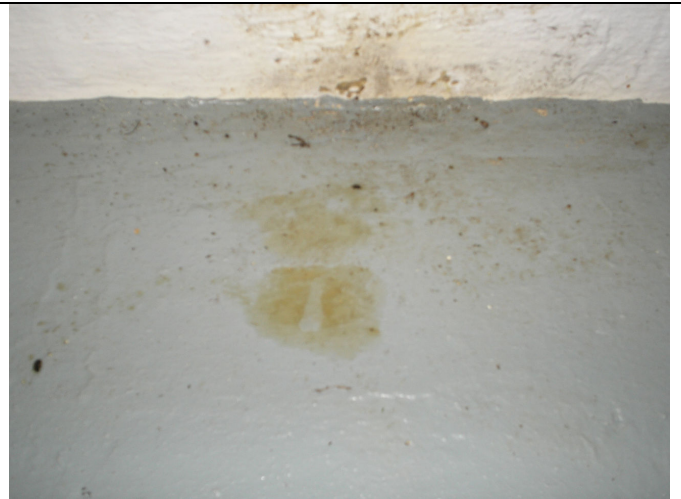
13. There are indications of water penetration to the basement evident mainly by moisture and high meter readings. Unable to determine the cause or source of the leak. You may wish to consult a structural engineer and/or drainage specialists for further evaluation.

Moisture in basement.
